From: [Heeley, Donald \(DEP\)](#)
To: [Bazenas, Ted](#)
Cc: [Kronopolus, John \(DEP\)](#); [Blackman, Anne \(DEP\)](#); [Levins, Gregory \(DEP\)](#)
Subject: 35 Pearl St LLC-Webster, MA
Date: Tuesday, September 29, 2015 12:52:30 PM
Attachments: [webster-2.pdf](#)
[Webster-Pearl35St-06-29-15-1A 005.JPG](#)
[aec_labs.pdf](#)

Re: Bulk Asbestos Results from Webster Factory

35 Pearl Street

35 Pearl St. Current Conditions

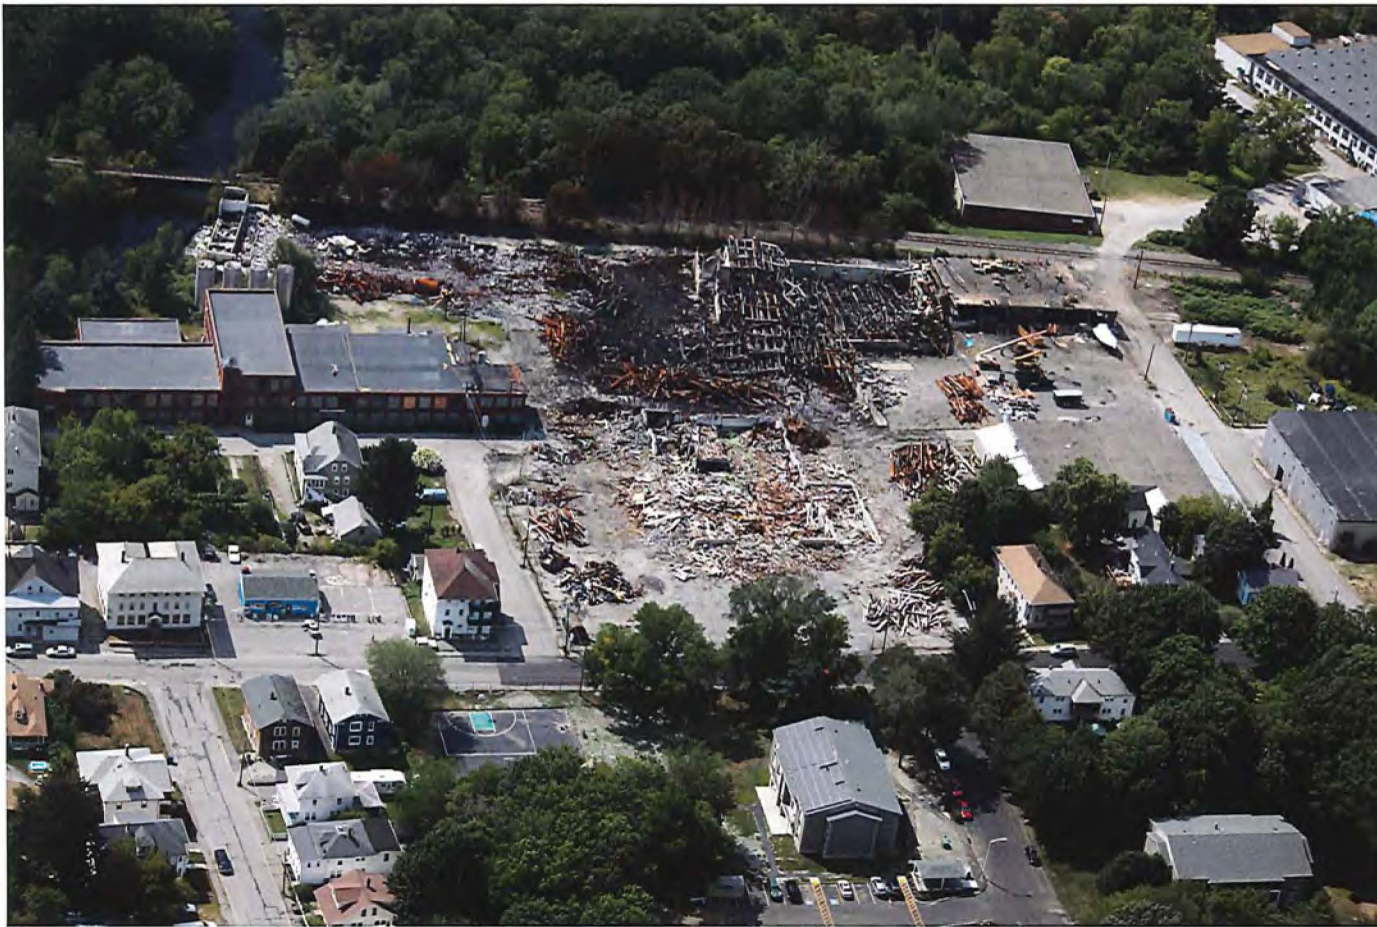
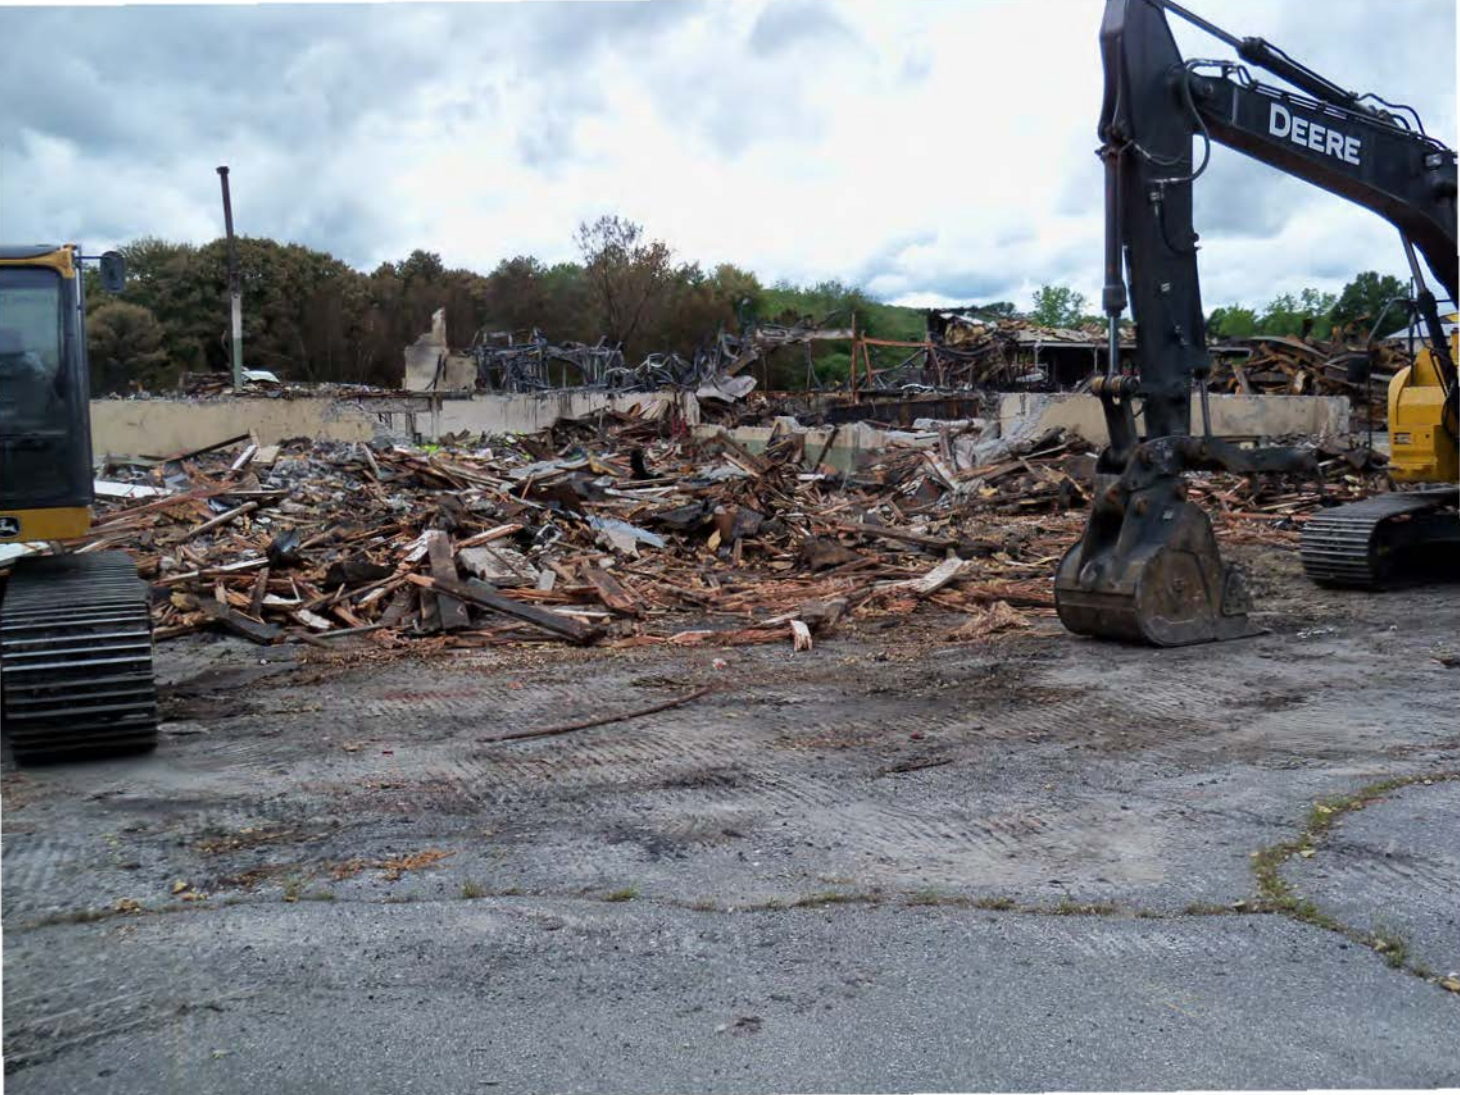
The mill building was destroyed by a catastrophic fire on June 25, 2015. The former mill complex is situated on approximately 9 acres located in a congested residential/commercial/industrial area of Webster, MA. The general public is in close proximity of this area. An apartment complex with basketball courts and a toddler playground are situated directly across the street from the fire site. Immediately after the fire, the Central Region MassDEP asbestos program was made aware through information obtained from a DLS licensed asbestos contractor and also a DLS licensed asbestos inspector retained by the property owner that exterior and interior asbestos containing materials were present throughout the buildings. The DLS licensed asbestos inspector provided MassDEP's asbestos program with the asbestos sampling results and a partial asbestos survey of the buildings. I have attached the sample results to this email for your review.

A few days after the fire, The MassDEP asbestos program conducted an inspection of the property accompanied by the aforementioned DLS licensed asbestos contractor and observed significant quantities of friable asbestos containing materials and non-friable asbestos containing materials that have been rendered friable co-mingled throughout the fire/demolition debris at the site. Based on our site observations and the sampling results, MassDEP considers all of the fire/demolition debris to be asbestos containing/asbestos contaminated. I have attached some pictures to this email for your review.

MassDEP's Central Region Deputy Regional Director, Senior Regional Counsel and Asbestos Coordinator believe there is an immediate need to perform the cleanup and decontamination of this property to prevent any possible migration of asbestos fibers and migration of possible unknown hazardous materials off the site via the ambient air or water pathways.

MassDEP is requesting the United States Environmental Protection Agency, Removal Program review this information to consider mobilizing to remediate this site as soon as possible.

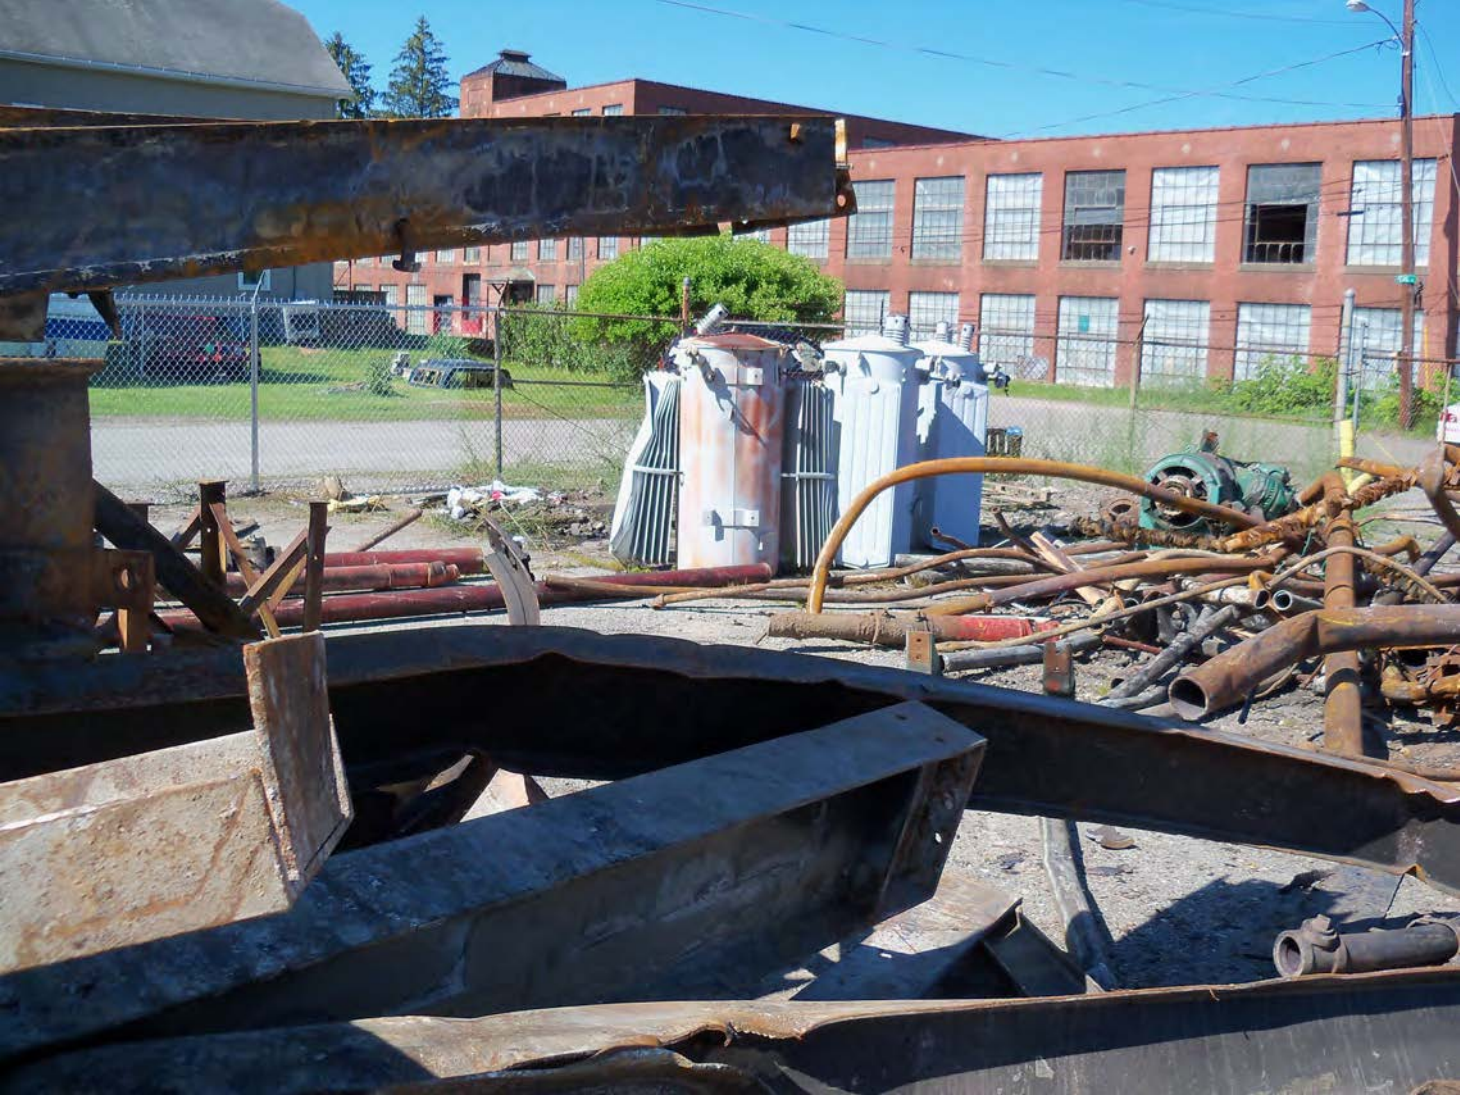
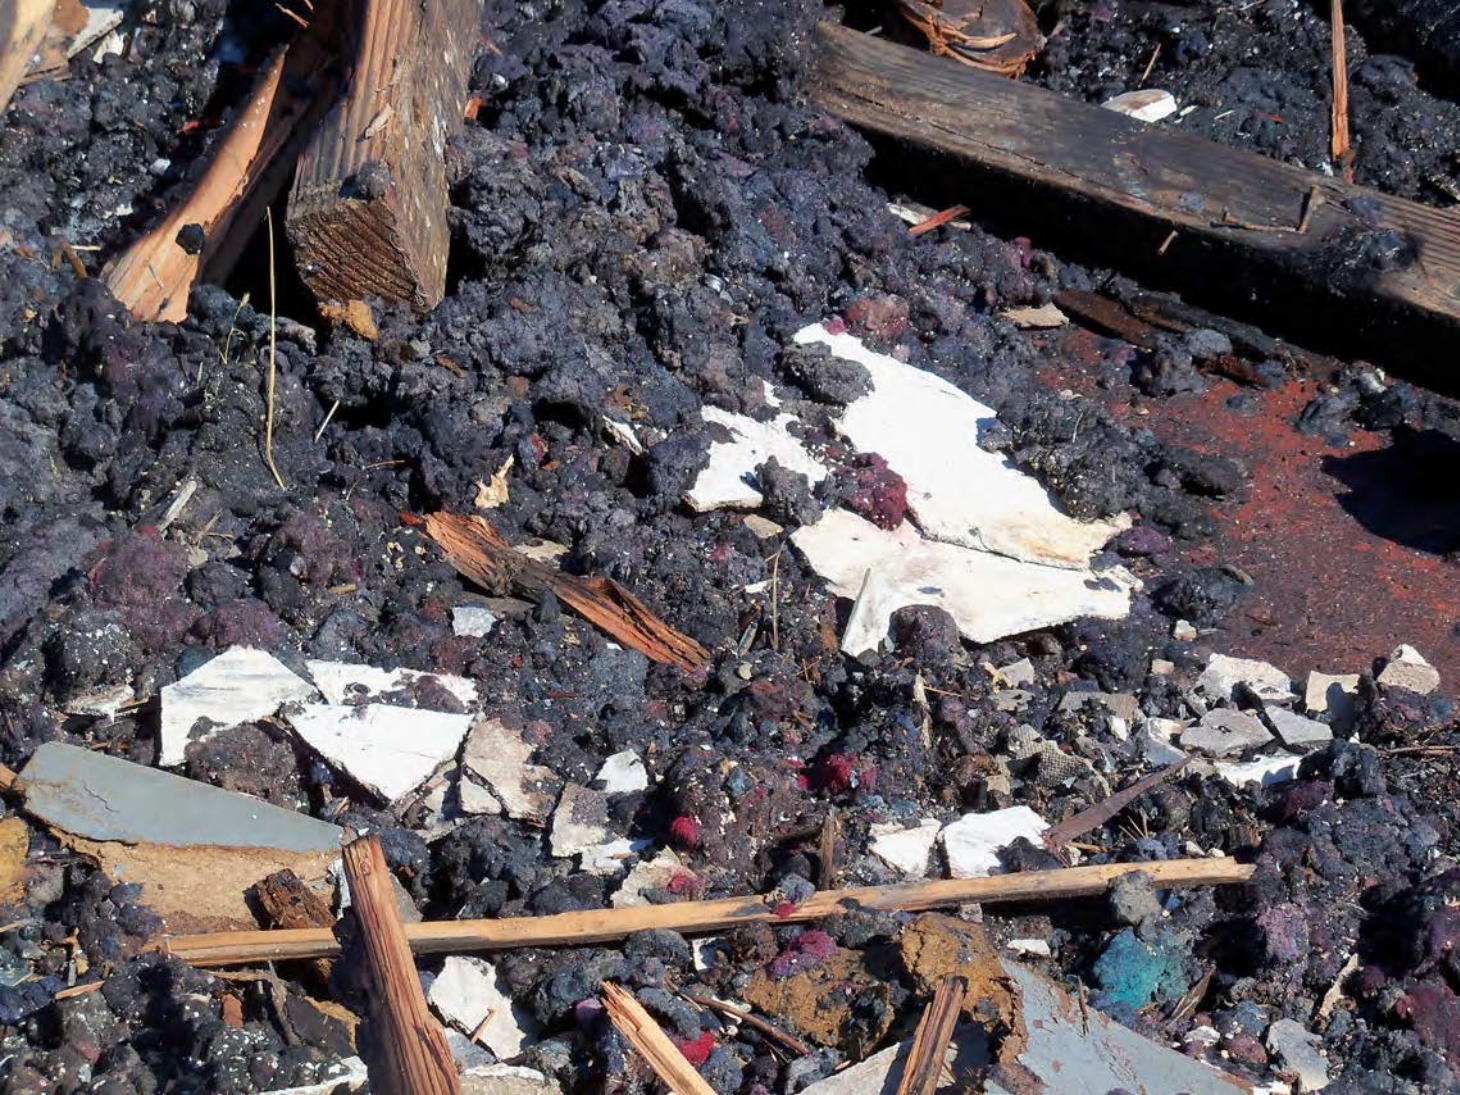
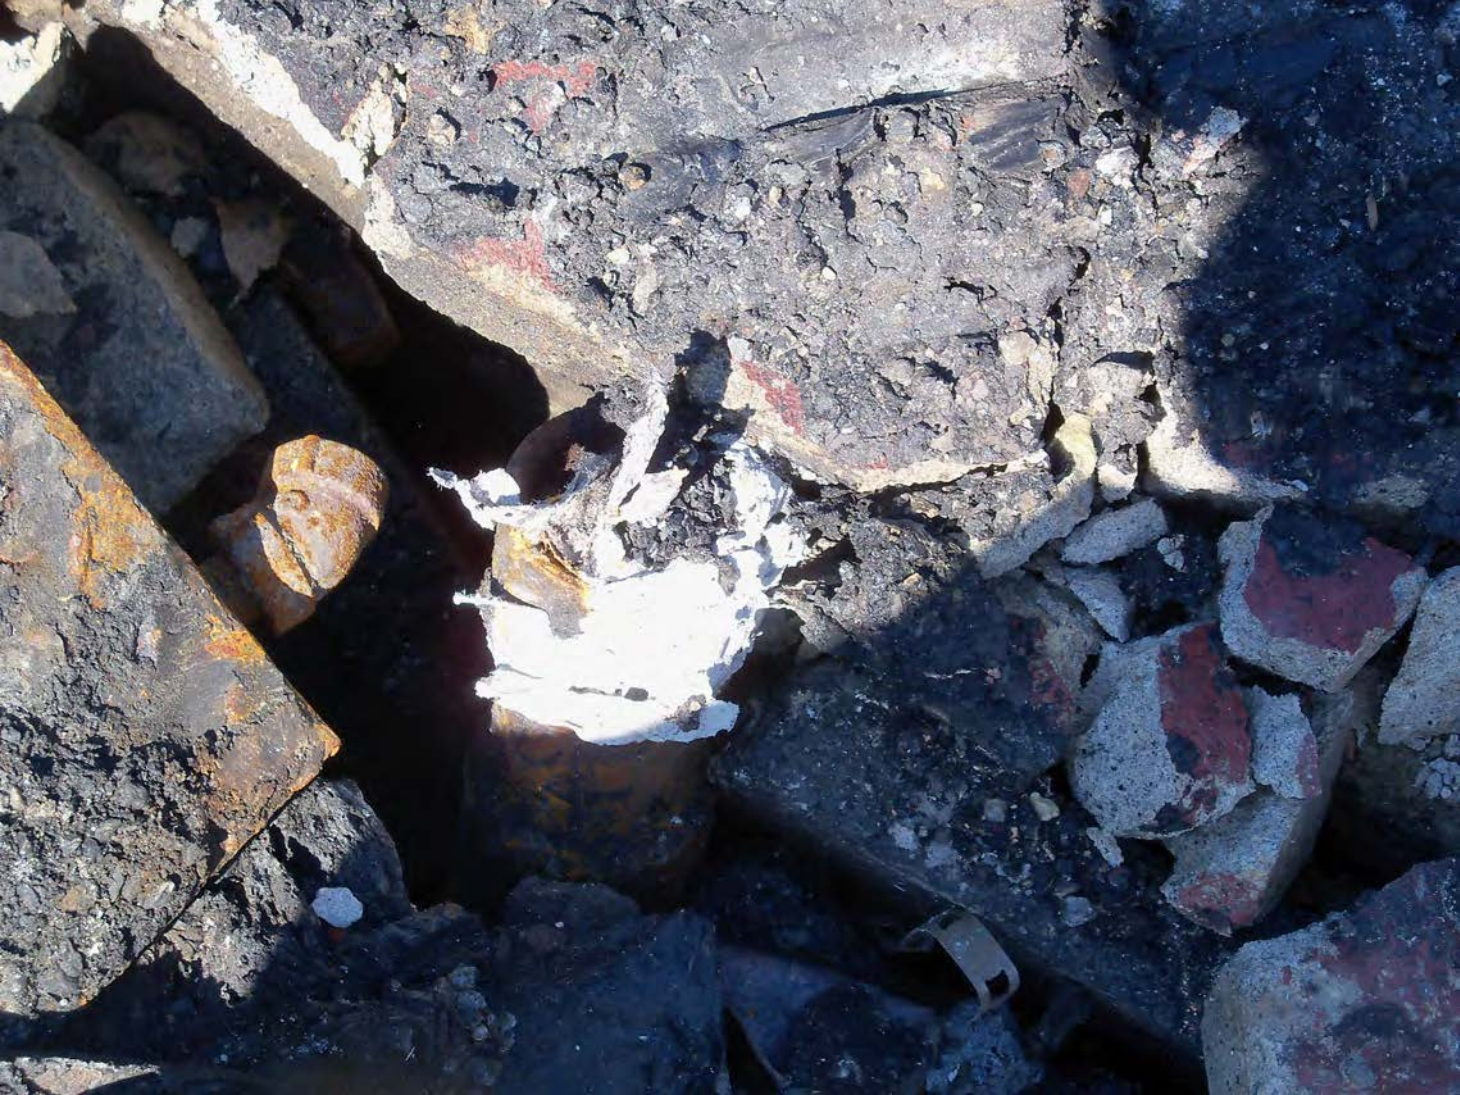
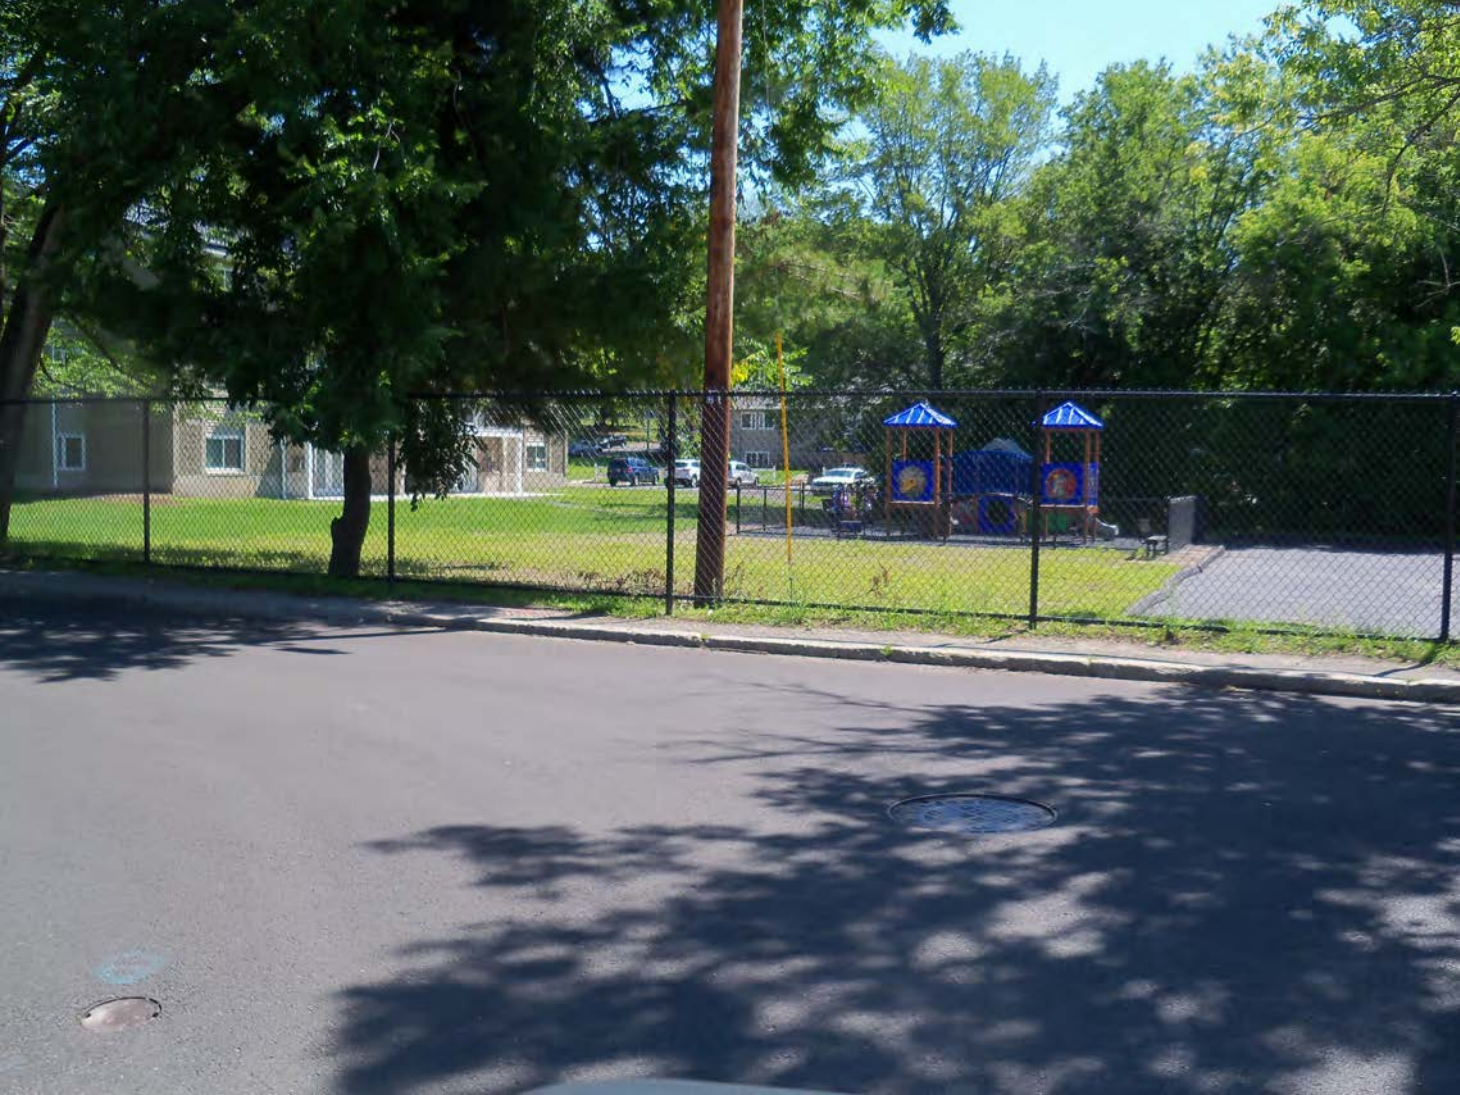
I am enclosing a few more pictures of the 35 Pearl St ,Webster MA site for your viewing.
